# ONBOARD SYSTEMS INTERNATIONAL

**Alert Service Letter** Document No. 159-025-00 Rev. 0

Subject: Verification of proper hook locked indication before performing external

load operations with cargo hook P/N 528-029-00 or -01

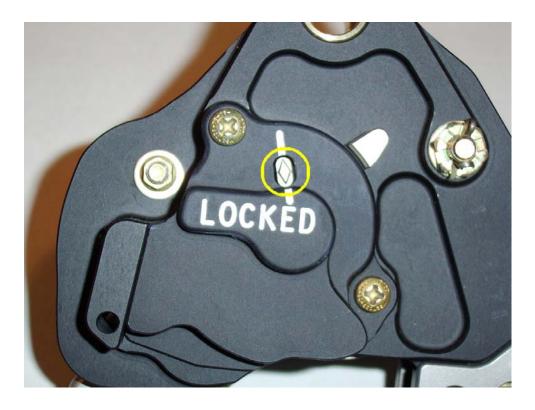
#### FIGURE 1

Picture of a cargo hook that is in the fully locked position. Note that the top and bottom corners of diamond shape showing through the opening of the lock indicator window (circled in yellow) are lined up with the white lines on the hook.

Onboard Systems would like to stress the importance of following the proper guidelines for verifying that the cargo hook P/N 528-029-00 or -01 is locked before performing any external load work. This is accomplished by verifying that the hook lock indicator on the side of the hook returns to the fully locked position every time the hook is latched. In the fully locked position, the top and bottom corners of the diamond shape on the hook locked indicator should align with the lines on the manual release cover (see Figure 1).

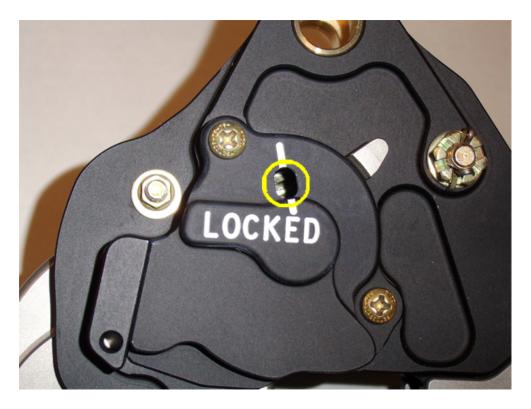
### FIGURE 2

If the hook does not re-latch properly (see Figure 2 and 3), it is critical that you do not use the hook until the problem is resolved, as an inadvertent load loss could result. Some possible causes for not re-latching properly include incorrect rigging and routing of the manual release cable, a cable that that is worn, binds or sticks and prevents the hook mechanism from locking, incorrect cable part number or release fitting installed or lack of proper maintenance. In addition, the load beam may close and feel secure, but the mechanism is not in a stable locked position unless the lock indicator returns to the fully locked position.

Picture of a cargo hook that is in the open position. Note that the locked indicator window (circled in yellow) is empty. This hook is not fully locked.

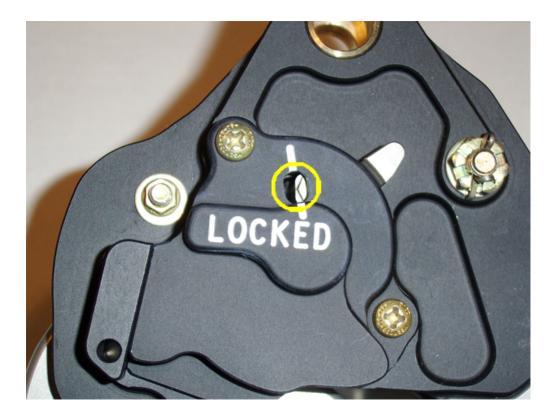
### FIGURE 3

Picture of a cargo hook that is not fully relatched. Note that while the edge of the metal indicator is lined up with the white lines on the hook, the top and bottom corners of diamond shape showing through the opening of the lock indicator window (circled in yellow) are not. This hook is not fully locked.
