SERVICE BULLETIN

Document No. 159-015-00, Rev. 0

Subject: R-44 and R-22 Cargo Hook Gimbal.

Helicopters Affected: Robinson R-44 and R-22 series with Onboard Systems Cargo Hook Kits installed under FAA STC SR01064SE, SR00578SE, SR00557SE or SR00920SE.

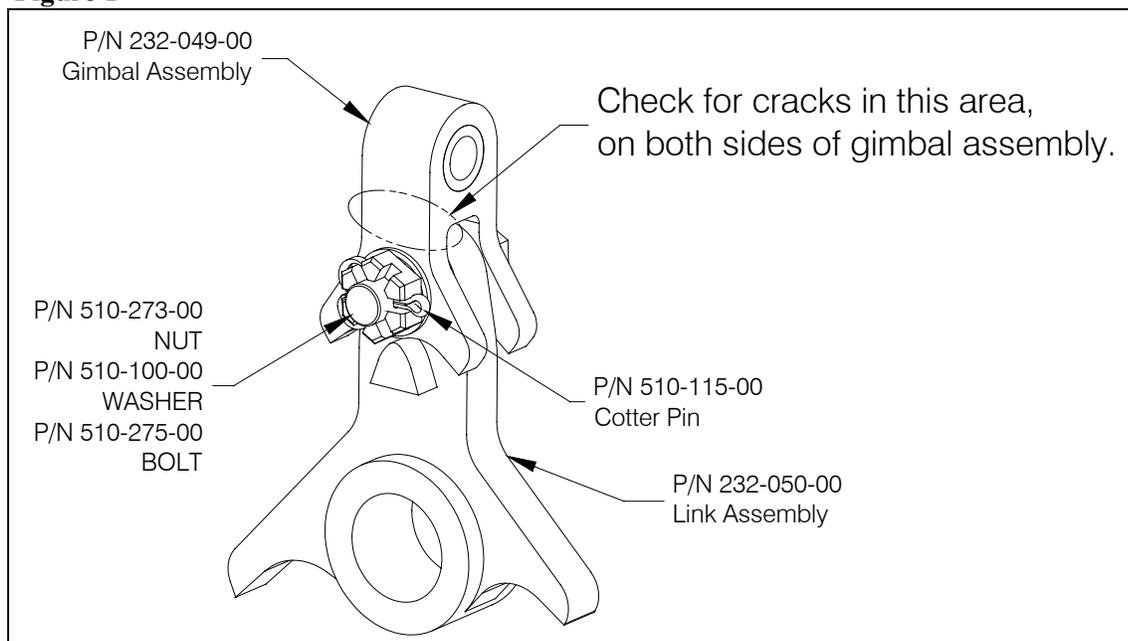
Figure 1

Description: On or about June 16, 2005, an operator of an R-44 flying a fertilizer bucket experienced a failure of the P/N 232-049-00 Gimbal Assembly. This part is a link that goes between the helicopter and the cargo hook. Failure of this part caused the bucket, rigging and cargo hook to separate from the aircraft. As the hook departed, the manual release cable pulled the hook open, releasing the bucket and rigging. The bucket fell to the ground and the hook stayed with the aircraft hanging by the manual release cable. The helicopter landed safely with damage to an inspection panel on the belly.

Pictures of the failed parts were sent to Onboard Systems and from those pictures and some additional stress analysis we have developed a theory about the cause of the failure. The two biggest and most likely factors appear to be torque loading from the fertilizer bucket and tension on the ears of the gimbal from tightening the bolt and nut that attach the link assembly.

The torque loading comes from counteracting the torque of the slinger on the bucket. In the absence of aerodynamic aids such as rudders or tails on the bucket this torque is transmitted through the rigging up to the spreader bar, eventually being reacted through the hook and gimbal. Excessive tightening of the NAS6604 bolt that attaches the 232-050-01 link assembly to the gimbal will cause a residual tensile stress in the lug at the point of crack initiation in this case. It was probably a combination of these two and possibly some other factors still under investigation that led to the failure.

1. To be accomplished within 10 days of the release of this service bulletin: Remove P/N 510-115-00 cotter pin and loosen P/N 510-273-00 Nut. Tighten nut finger tight and then tighten to next available slot for cotter pin. Install new cotter pin.
2. To be accomplished within 10 days of the release of this service bulletin and then repeated every 8 hours of fertilizer bucket hook time: Visually inspect P/N 232-049-00 gimbal assembly for cracks in areas noted within Figure 1. If cracks are found replace gimbal before further use.
