SERVICE BULLETIN

Document No. 159-013-00, Rev. 0
May 12, 2004

Subject: AS350 Swing Cracking.

Helicopters Affected: Eurocopter AS 350 series with Onboard Systems swing type suspension system installed. STC SR01164SE and SR01393SE.

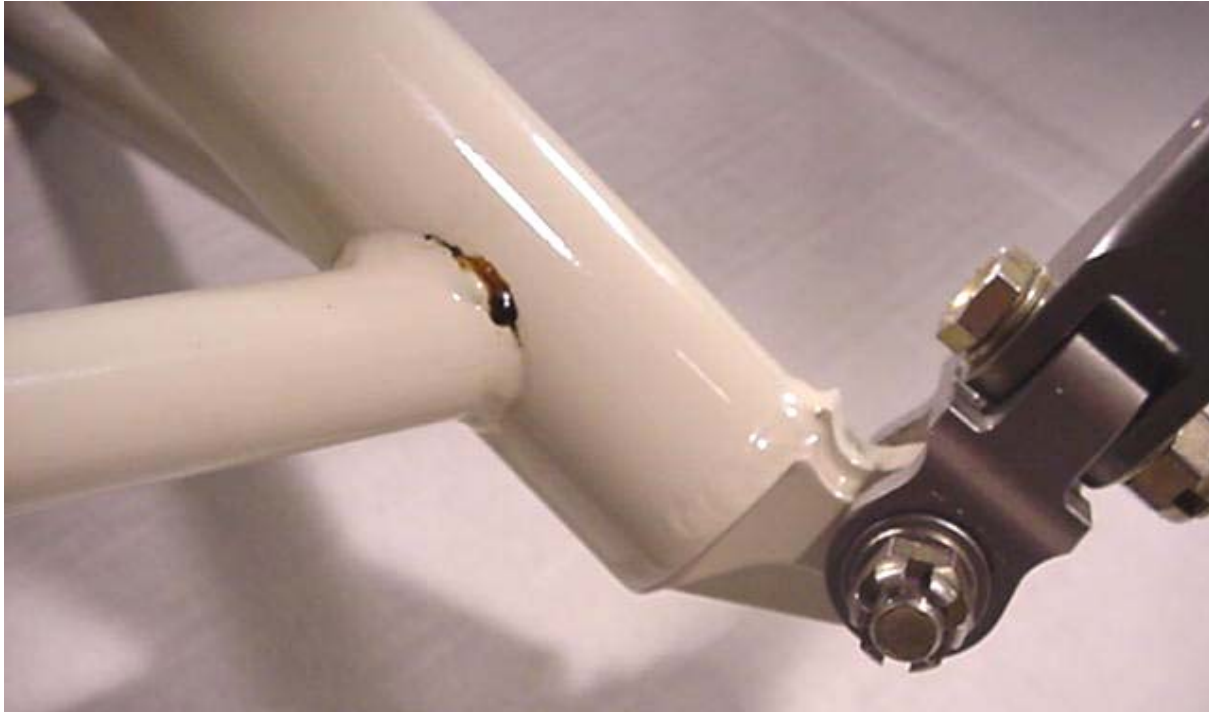
The swing frame referenced above (weldment P/N 235-096-00) has had several incidences of cracks developing around the welds that join the small horizontal tubes with the main tubes. Please see attached photo for an example of typical size and location. These cracks have developed after 300-350 hook hours of logging and siezmic work. The cracks are slow growing and do not present an immediate safety concern, however the frame should be replaced within 8 flight hours after they appear. They will usually be accompanied by oil weeping from the crack as the tubes have a corrosion preventative oil inside.

Typical crack with corrosion preventative oil leaking out.

1. Visually inspect frame welds for cracks. Pull plastic spiral wrap back as required to expose welds. If cracks are found replace frame within 8 flight hours. If cracks are longer than 20 mm replace frame immediately. Do not attempt to weld repair the cracks as the frames are heat treated and the welding will affect the heat treat. Also fusion of the crack would be nearly impossible due to the oil in the tubes.
