SERVICE BULLETIN

Document No. 159-020-00 Rev. 0

Subject: Bell 206L/407 Cargo Hook Suspension System failure.

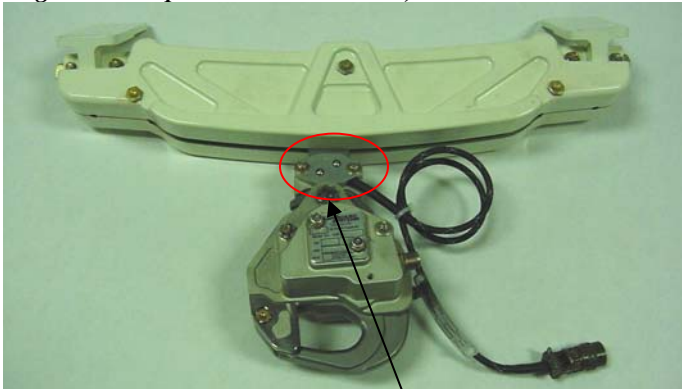
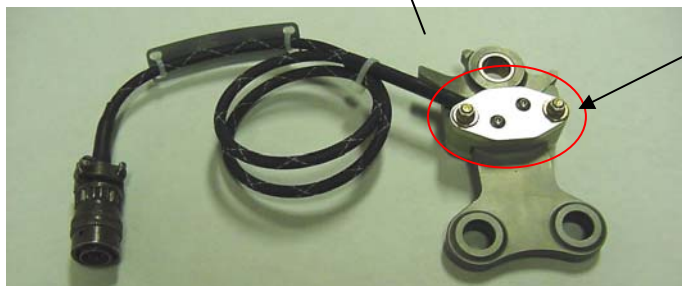
Figure 1. Suspect Part: 210-179-00, E-85 Load Cell

Description: Onboard Systems has had one reported case of failure of the E-85 Load Cell, 210-179-00 and two known instances of unrepairable damage to the same Load Cell. This Load Cell is a component of the Cargo Hook Suspension Assembly used on several models of the Bell 206L / 407 helicopter and is shown below in Figure 1.

Failure Area
Under Cover

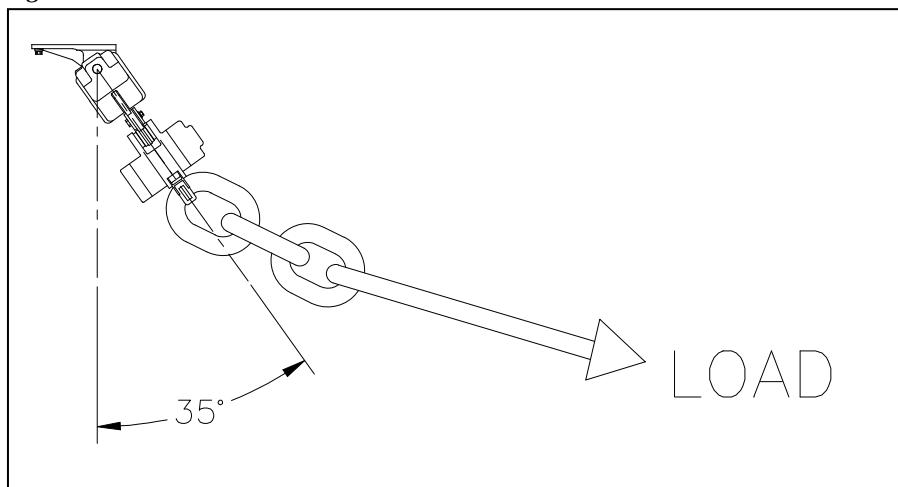
Figure 2. Adverse condition

Cause: Investigation has shown that failure of the Load Cell resulted from excessive bending stresses.

In the typical operational mode of the Cargo Suspension System, the Load Cell is not subject to bending. The Cargo Suspension system is designed to accommodate loads through an angle of up to 35°—both forward and aft. However, when loads exceed 35°, the travel stops on the Pillow Blocks prevent the Suspension Beam from further rotation and cause bending stresses to be carried by the Load Cell.

The situation is most likely to occur when flying at high speed with light loads which have large aerodynamic drag. For example, an empty fire or fertilizer bucket or an empty long line. Figure 2 illustrates the adverse loading situation.
