**ONBOARD SYSTEMS  
INTERNATIONAL**

## Alert Service Letter

Document No. 159-029-00 Rev. 0

**Subject:** Revised load ring sizes limitations for the TALON 3K Remote Cargo Hook P/N 528-018-01 and -02.

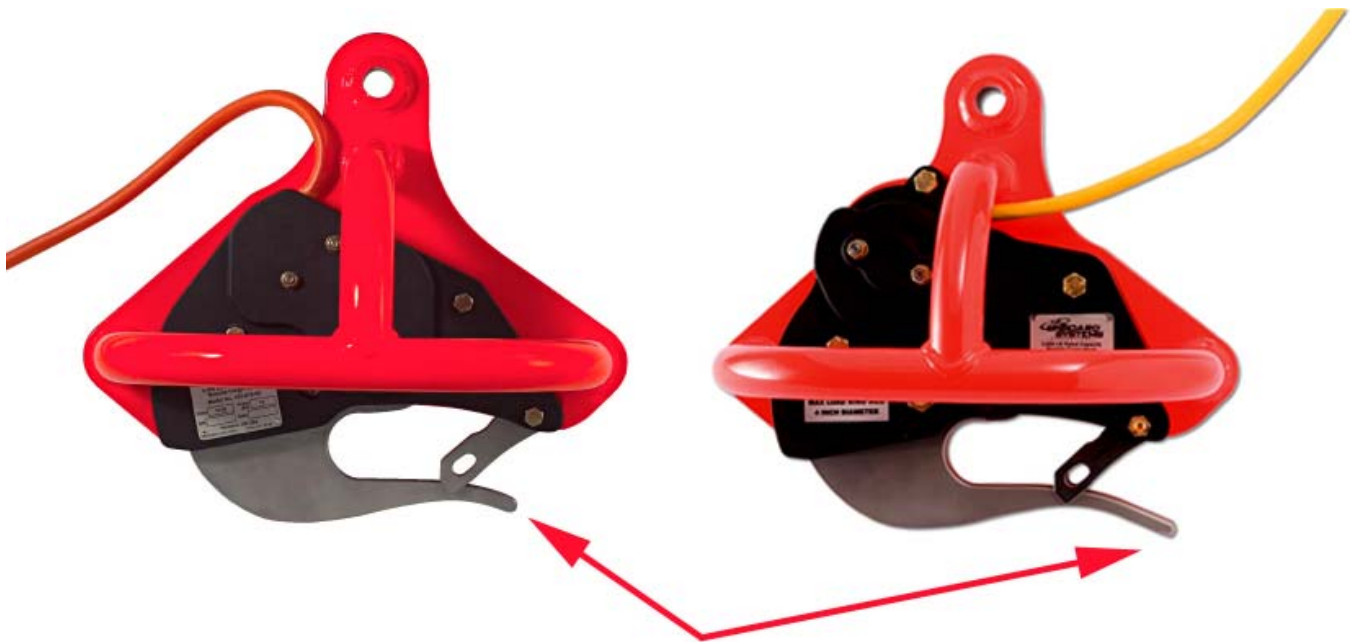
*This Alert Service Letter is only applicable to TALON 3K Remote Hooks that are equipped with the longer load beam, P/N 290-683-01, and that include a "Warning Decal for 4-inch Rigging" applied to the side plate (please refer to Figure 1).*

**FIGURE 1** — Side-by-side pictures of the TALON 3K Remote Hook with the shorter and longer load beam configurations. The photo on the right shows the longer load beam configuration; this hook is affected by the Alert Service Letter. The photo on the left shows the shorter load beam configuration; this hook is not affected by the Alert Service Letter. For this configuration, it is the responsibility of the operator to ensure that cargo hook will function and release properly with each individual rigging configuration.

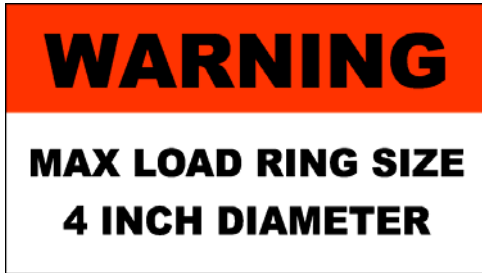
It has been determined that the load ring sizes originally recommended for this hook are inadequate to prevent the load ring from rolling out past the keeper under all operating conditions. These size restrictions have been modified to correct this issue.

FIGURE 2 — Picture of old decal

2. Remove the old warning decal (please refer to Figure 2) from the hook side plate and replace with the new warning decal P/N 215-203-00 (please refer to Figure 3).

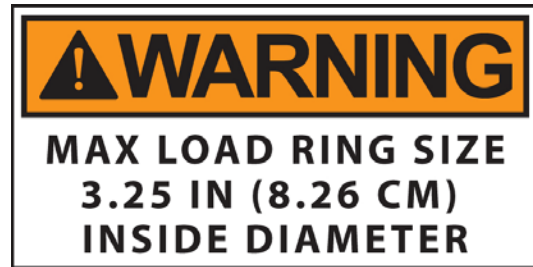
FIGURE 3 — Picture of new decal
