SERVICE BULLETIN

Subject: Bell 407 Suspension Beam Interference

Helicopters Affected: Bell 407

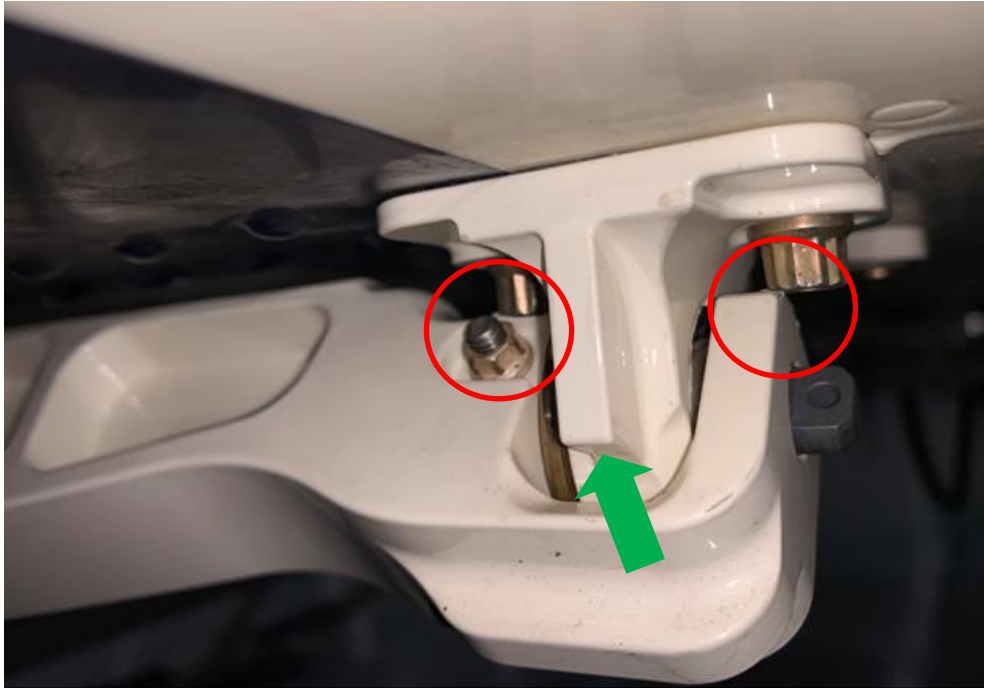
Description: Onboard Systems has been notified of interference between the Bell 407 Suspension Beam and Pillow Block mounting fasteners. This interference can act as an unintended travel limiter in the aft direction and cause fretting wear on the Suspension Beam.

Figure 1 – Unintended travel stop at fastener heads (circles) versus intended travel stop (arrow) of Suspension Beam.

- 1) **Check Beam for sign of interference.** Inspect the Bell 407 Suspension Beam by pivoting it towards the aft direction, as far as possible. Ensure that the Suspension Beam makes full travel to the stop present at the Pillow Block. Verify that the Pillow Block mounting fastener head is not an unintended travel stop. Ensure sign of contact (paint chipping, fretting) is not present.

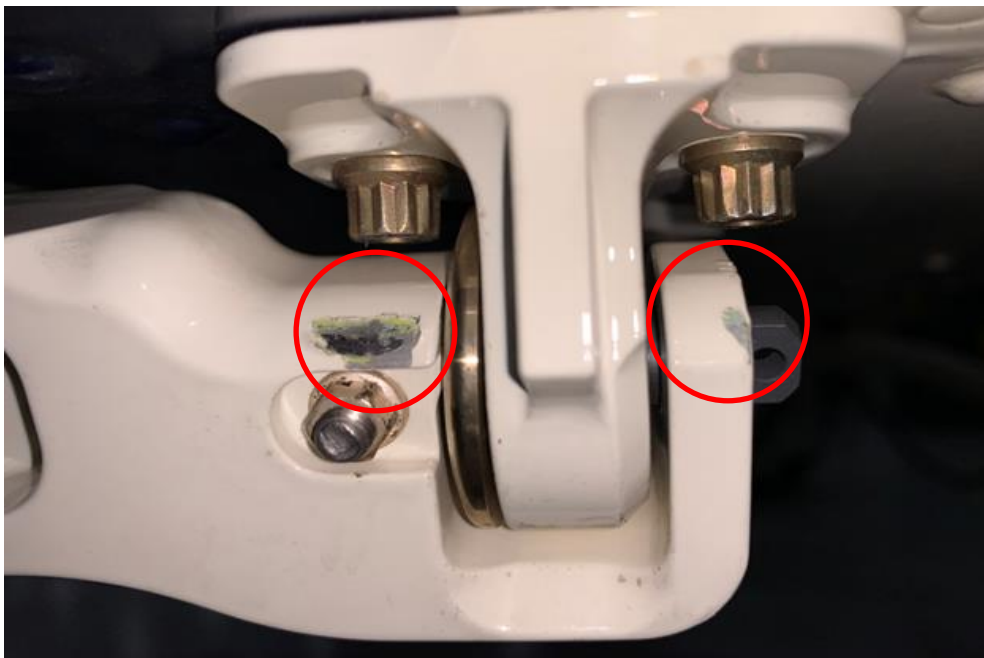
Figure 2 – Paint chipping evidence

- 2) If unintended contact is *not* found, no further action is required related to this service bulletin. If unintended contact *is* observed, proceed to the accomplishment instructions section.

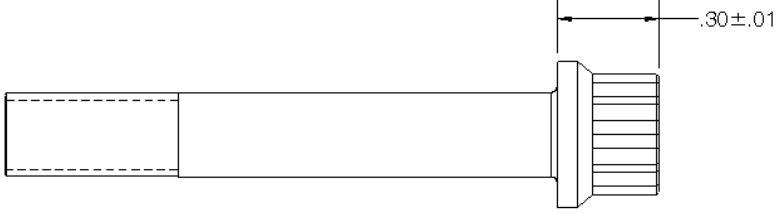
<p>MS21250-04020 MS21250-04018</p>

Measure the head height of the 12-point attachment screws (P/N 510-725-00) of the Pillow Blocks using calipers per Table 3 (also See Figure 1). If the fastener head does *not* measure $0.25 \pm .010$ inches [$6.35 \pm .25$ mm], remove and replace fasteners per the instructions in this section.

Table 3 – OK / Not OK Fastener Comparison (P/N 510-725-00)

2. One at a time, remove and replace offending fasteners, P/N 510-725-00. Note: the Pillow Blocks *do not* need to be fully removed from the aircraft (they are typically sealed in place). Replace self-locking nuts (P/N 510-234-00) with new and torque nuts to 84 – 107 in-lb [9.1 – 12.1 Nm], plus drag torque. See figure 4 below:

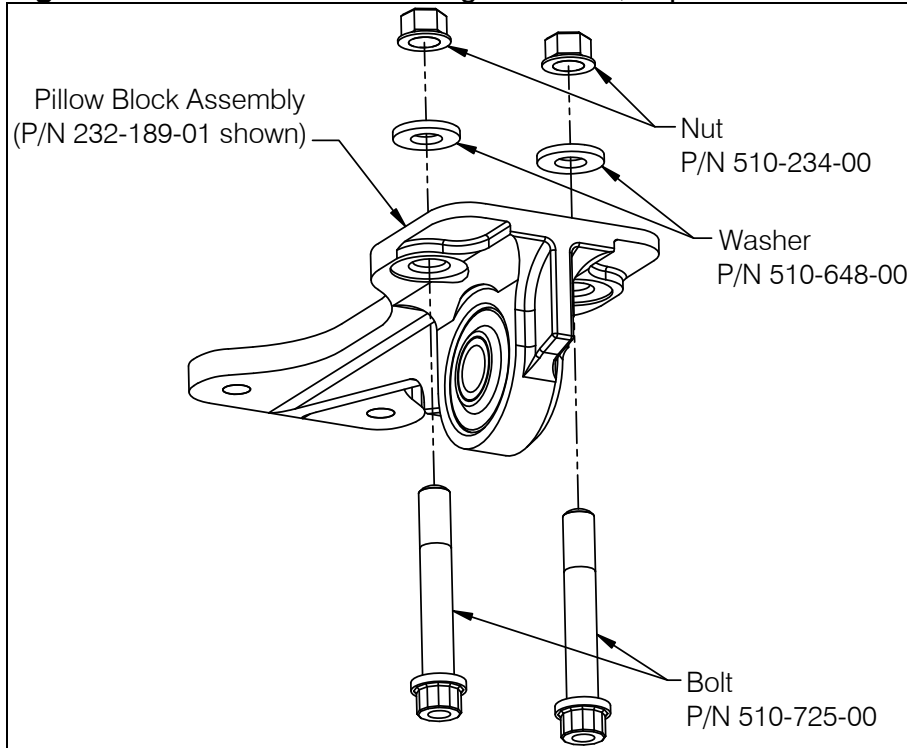
Figure 4 – Pillow Block mounting fasteners, exploded view

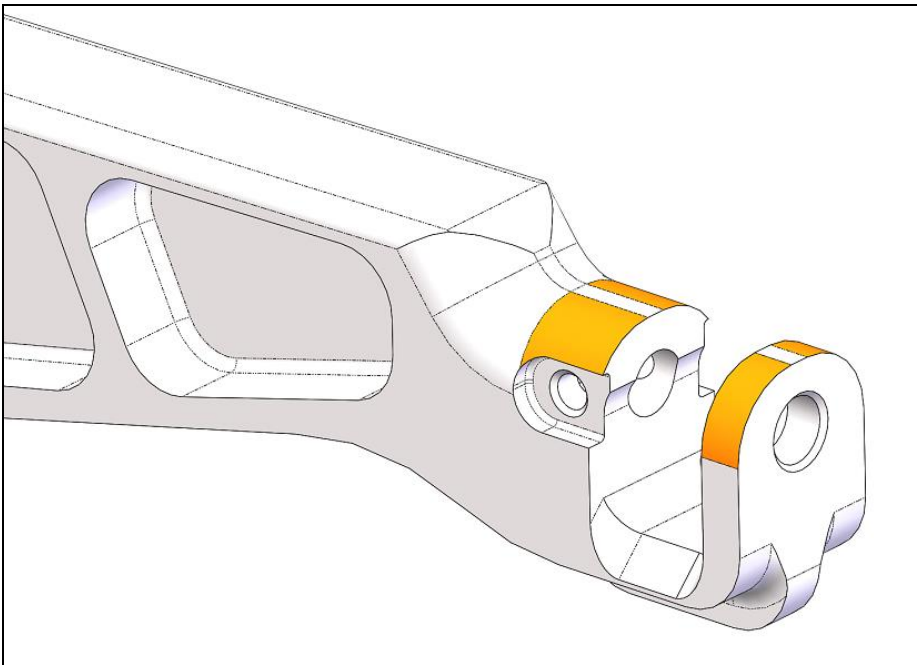
Investigation has revealed that the interference may occur due to two contributing factors: 1) utilization of fastener series MS21250 (versus MS21134), and 2) a machining nonconformance present in certain lots of the Suspension Beam.

Figure 5 – Suspension Beam rework areas

5. Accomplishment of this section requires returning the Beam (P/N 290-852-01) to Onboard Systems for rework. As CNC machining is involved, the rework modification is not readily accomplished in the field. Onboard Systems will re-machine, inspect & re-finish the Suspension Beam lug areas to drawing conformance in the filleted areas shown in Figure 5.

6. Once the Suspension Beam has been reworked, re-install per Owner's Manual instructions and verify the Suspension Beam can make full aft travel unimpeded. If interference is still observed, contact Onboard Systems for further direction.
